NPDES Inspection Report

Permit # WAR05I001

Omak Forest Products, LLC

September 15, 2016

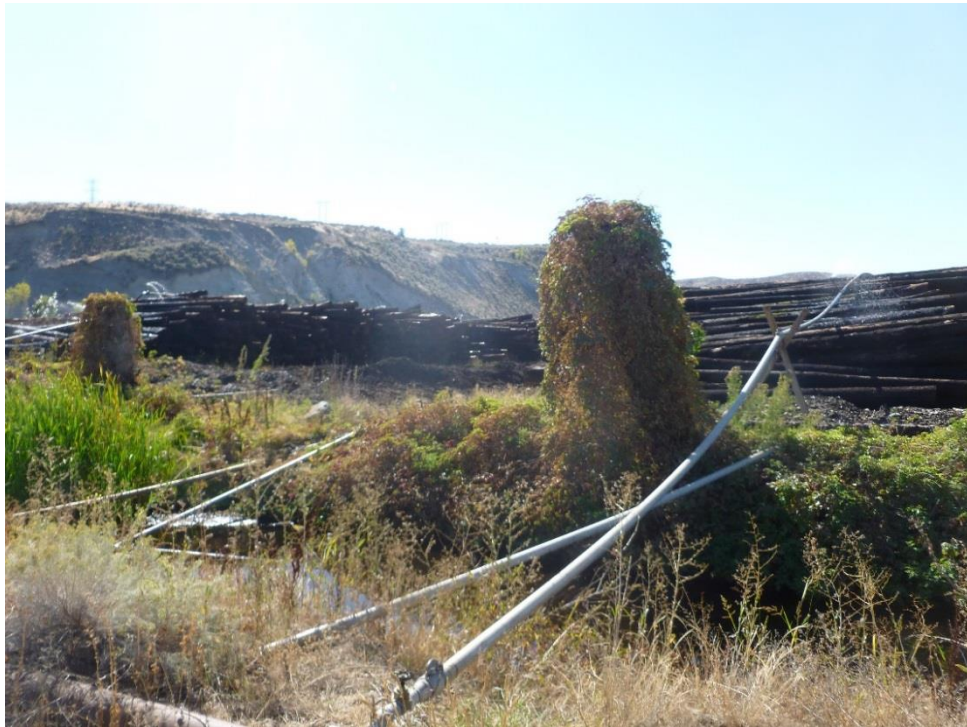
The catchment pond drains to a sump (**Photo 5**) in the northeast corner of the property. This flow is augmented by well water and sprayed onto the log piles (**Photo 6**) to keep the logs fresh.

Photo 6 / P1020731 – Southwesterly view of the log pile area from Omak Avenue. The catchment pond appears in the foreground.

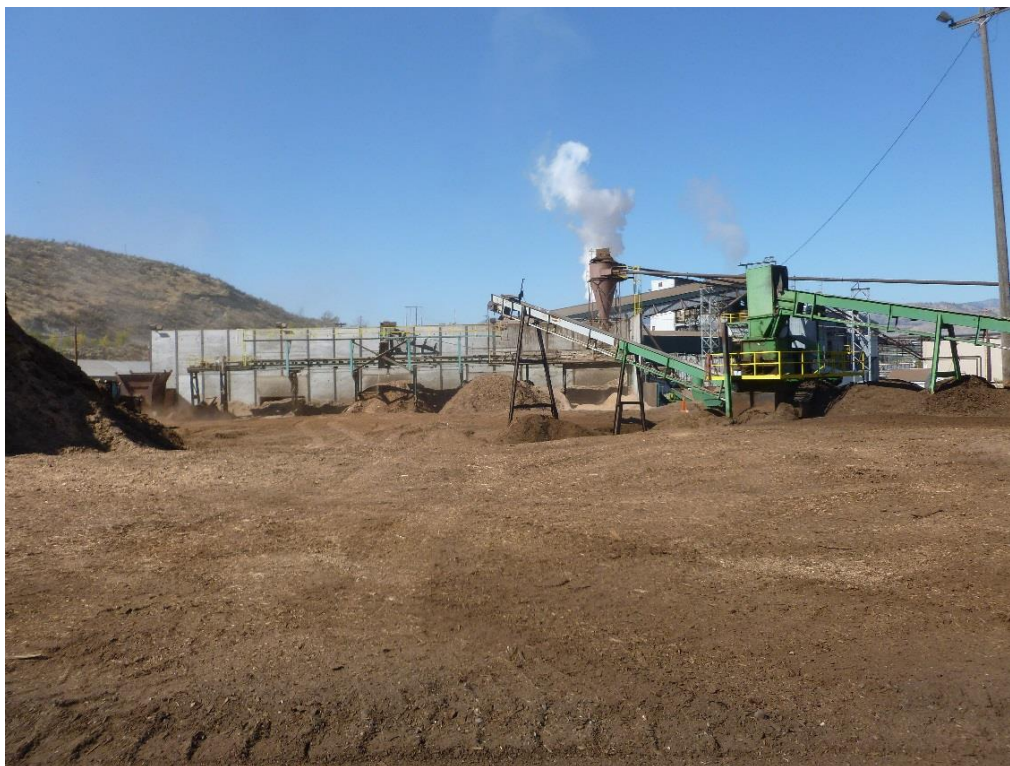
I inspected the hog fuel processing area and conveyor system (**Photo 11**), which is used to fuel the boiler. In the unpaved area south of the conveyor system, I observed pooling water from a leaking spigot (**Photo 12**). I also observed an open container of wet ash (**Photo 13**) scrubbed from the boiler exhaust. Mr. Epperson said this wet ash waste is taken to a nearby tribal solid waste landfill for disposal. South of the boiler, I observed an open dumpster and bags of salt stacked on the pavement (**Photo 14**).

Photo 11 / P1020712 – Westerly view of the boiler and hog fuel processing area

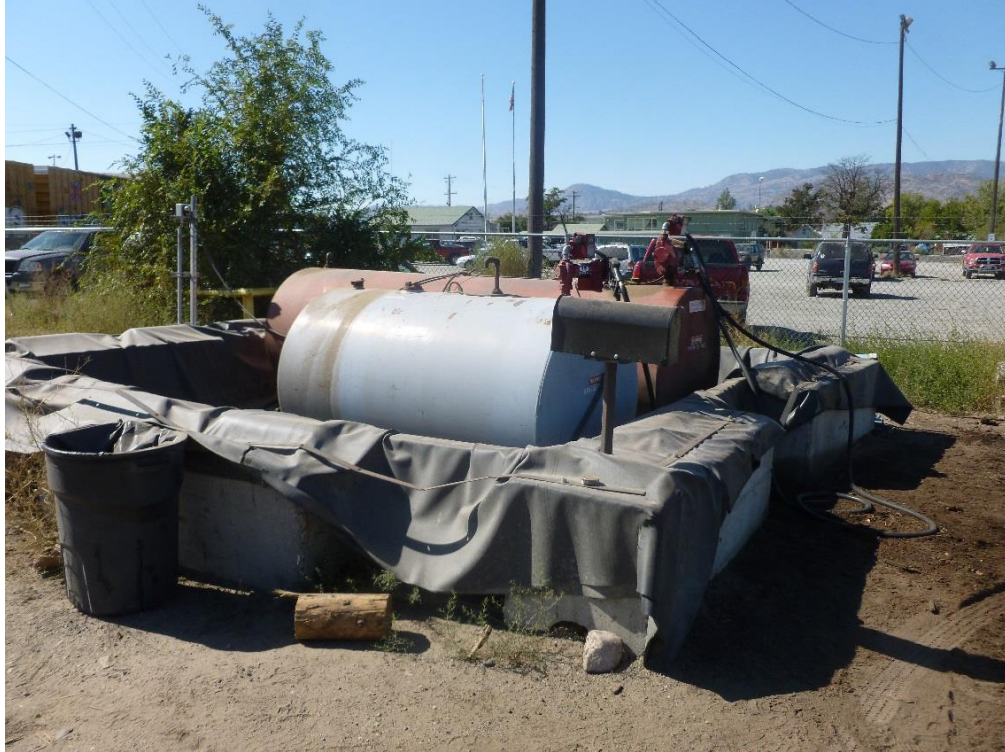
Also near the plywood plant, I observed another open dumpster (**Photo 30**) and an outdoor fueling station (**Photo 31**). To the north of the plywood plant, I also inspected the unpaved delivery entrance (**Photo 32**) to the facility. In this area, I observed dust in the air from industrial vehicle traffic and dirt tracked onto Omak Avenue (**Photo 33**).

Photo 31 / P1020749 – Fuel tanks
